The *Lincoln* / MERCURY Old Parts Store

Attention: 1958-1960 Lincoln Owner

BAK-5723580-B - WORM GEAR AND COUPLING - DRIVE POWER WINDOW

Coupler fix for Lincolns.

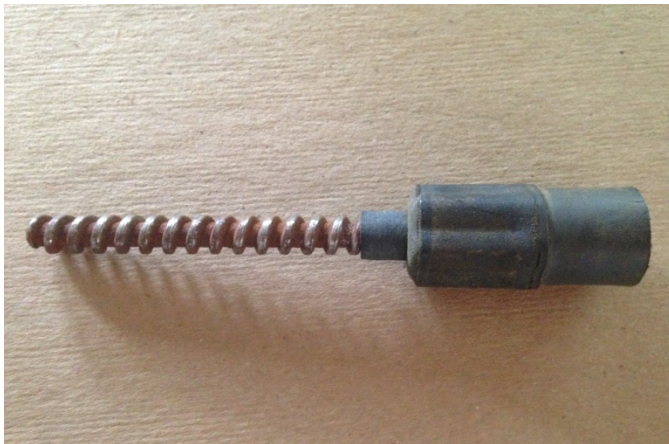
We have come up with a repair for the late 1958, 59 and 60. What happens is that, over time, the metal star wheel imbedded in the rubber coupler works itself loose from the rubber couple. The symptoms are usually the window motor is running but the window won't go either up or down. Another symptom is the window will move but chatters or ratchets when either going up or down, or both.

1. Remove the window motor from the window regulator and clean the motor shaft and star wheel.
2. Without removing the regulator, clean the inside of the rubber coupler that the shaft and star wheel fit into.
3. Apply a small amount of 2-part epoxy (like JB Weld) into the rubber coupler where the motor shaft and star wheel go.
4. Reinstall the motor into the coupler and wipe any epoxy around the area the motor shaft meets the coupler to cover the shaft and star wheel.
5. Tighten the motor to the regulator
6. Allow the epoxy to harden overnight
7. The result should be good for many trouble free miles.
